Acoustic Emission Monitoring of the Turin Cathedral Bell Tower: Foreshock and Aftershock Discrimination

Acoustic Emission Monitoring of the Turin Cathedral Bell Tower: Foreshock and Aftershock Discrimination / MANUELLO BERTETTO, AMEDEO DOMENICO BERNARDO; Masera, Davide; Carpinteri, Alberto. - In: APPLIED SCIENCES. - ISSN 2076-3417. - ELETTRONICO. - 10:3931(2020), pp. 1-23. [10.3390/app10113931]

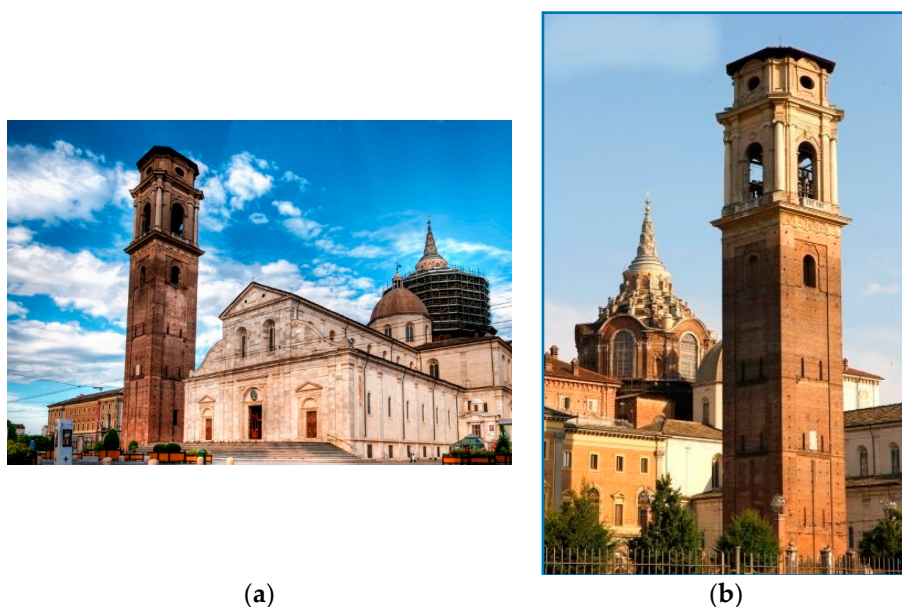
Figure 1. Architectural complex of the Cathedral with the bell tower in the front and the dome erected by G. Guarini: (a) on the backside; (b) view of the isolated bell tower from the other side

The bell tower was initially built in the second half of the 15th century between 1468 and 1470 [11,12]. Recently restored, the tower is inserted, today, in the Diocesan Museum of the Sabaudian city (see Figure 1). The masonry tower was erected completely by the will of bishop Giovanni di Compey (Figure 1a). Between 1720 and 1722, the court architect Filippo Juvarra worked on the crowning and the dome, the tower assumed its current appearance—a brick construction that ends with a baroque bell tower made by stone decorations [11,12] (see Figures 1b and 2).

Christian churches, still marked at the top by the opening of the ancient bell cell; and the 18th-century crowning—the unfinished realization of Filippo Juvarra’s project (Figure 2b). The ancient part is a square plan of about 10 meters (9.70×9.70) on each side with perimeter walls of a constant thickness (2 m) up to the Juvarrian crown, where, in correspondence to the bell cell, the square is connected to an octagon. The restorations of the 1980s were followed up in 2013 by the architects Maurizio and Chiara Momo. In the last few years, the bell tower was subjected to the last external restoration works that completely returned the tower to the city in all its magnificence (Figure 1b).

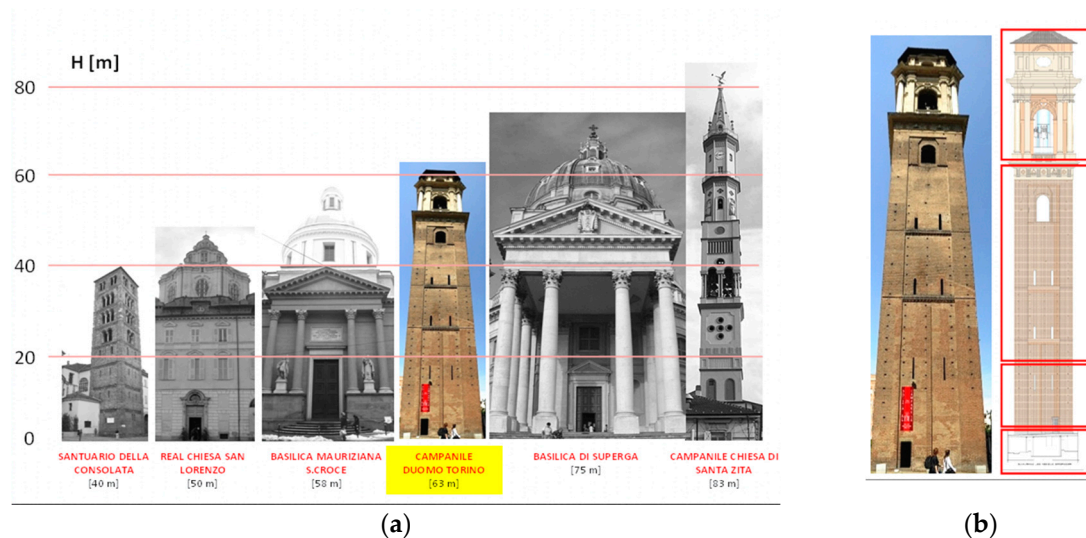
Figure 2. Tall masonry building in Turin and parts constituting the bell tower. (a) The bell tower is the third tallest masonry building in the city (63 m); (b) The tower is subdivided into different parts—the stem and the bell cell are constituted by different materials and were erected in different times and by different building techniques.

The bell tower is today the third tallest masonry building in the City, (63 m) (see Figure 2a). As mentioned, the structure, finished around 1470, was built next to the paleochristian complex of the so-called three churches, the communicating buildings of San Salvatore, Santa Maria, and San Giovanni Battista. Successively, the structure was incorporated into the building of San Giovanni. About 20 years later, the churches were destroyed, and in their place, the city's cathedral was built. The brilliant architect Meo del Caprina designed the cathedral, and the original tower became the bell tower, connected to the church by an underground gallery that is now part of the Diocesan Museum (Figure 1a). The tower was restored for the first time in 1620, and a century after, the design of Filippo Juvarra was completed for the top cell and the roof. When the Palazzo Vecchio was demolished in the 19th century, the bell tower remained isolated and ignored until 1986, when contemporary restorations were started by the architects Maurizio and Giuseppe Momo. The tower, therefore, consists of two distinct parts: the 15th-century tower, with a squared plan erected on the site of the early

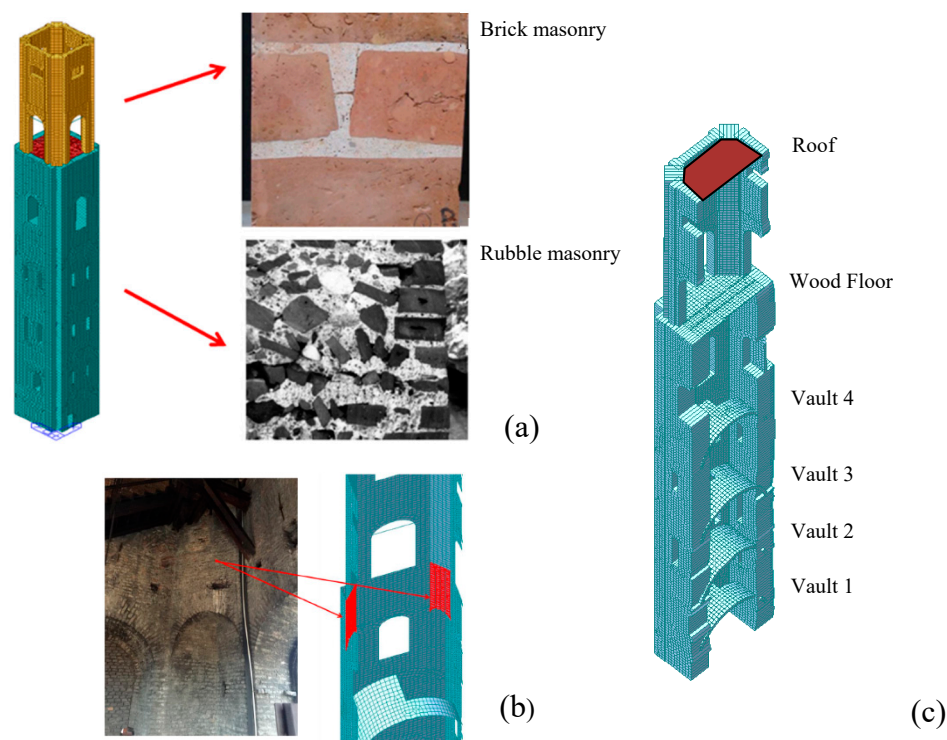
Figure 3. The FEM: (a) The bell tower is made with different materials and different building techniques (sack masonry). (b) Chains have also been inserted within the model in correspondence with the “key heads” observable from the outside. The loads of the various elements were assessed by multiplying their thickness by the specific weight of the materials. The different dead loads were associated to the different levels and structural elements. (c) Axonometric cross-section of the tower.

Starting from the results of the survey, FEM was implemented with the aid of Midas FX software (CSP Fea Engineering, Padova, Italy), a three-dimensional geometric modeler completed by the FEM modulus. Through the CAD (computer-aided drafting) reproduction, the geometric model of the tower was initially defined, from which, thanks to the software's auto-meshing function, the FEM model was obtained. In Figure 3, the model obtained is shown.

In addition, thin elements have been inserted (chain) (see Figure 3b), which act as connections between the two different parts of the tower—the stem and the cell. In this way, the loads of the bell cell are gradually transferred on the fifteenth-century part of the tower. Chains have also been inserted in the model in correspondence with the “key heads” observable from the outside; the external ‘keys’ and the inserted chains can be seen in Figure 3b. It can be observed that some chains do not circumscribe the tower; this is due to the fact that they have only been inserted in correspondence with the externally visible “keys.” This operation is therefore in favor of safety, since the chains are certainly less in number than those actually present in the structure.

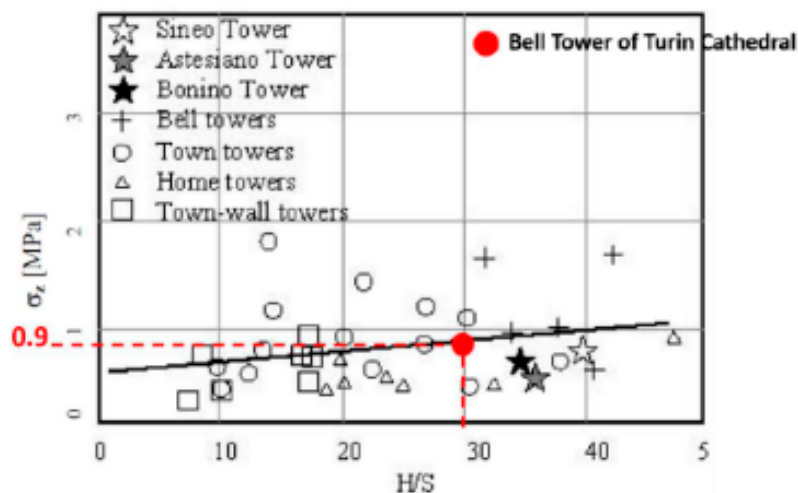
Figure 4. Compressive stress σ for different ancient tall masonry towers in Italy [22]. The maximum stress is reported as a function of the ratio between the height and the maximum depth of the bearing wall of the structure.

As far as the horizontal actions are concerned, the values of the seismic action and the pressure exerted by the wind on the tower were evaluated and implanted in the model. The weights of the various elements were assessed by multiplying their thickness by the specific weight of the materials, and in the case of the masonry vaults, taking into account a thickness equal to 30 cm and the specific weight equal to 18 kN/m^3 , a dead load of 5.0 daN is assumed. For the timber floor a thickness equal to 12 cm and a specific weight equal to 5.75 kN/mc is considered (Figure 3c,d). The vaults were considered susceptible to crowding, and therefore, an accidental load of 5 kN/m^2 is assumed. As for the roof and the facades, snow, wind, and seismic loads were considered according to the Italian rules for the evaluation of these kind of actions. Figure 4 shows a detail of the area where the highest vertical tension values were found; the value at the base of the tower stress value obtained is about 0.95 MPa. In addition, the calculation of the compression stress at the base of the tower can be carried out with a rough approximation: $\sigma = N/A = 66526/63.15 = 1.05 \text{ MPa}$. The stress value at the base of the tower obtained from the FEM model was compared with the results obtained [5–10] for different masonry towers and tall buildings. In particular, the values obtained for the tower are similar to that showed in the trend of vertical tensions as the reported heights of the towers [9].

In term of comparison to the real scenario, and in order to validate the results of the implemented model, the value of the maximum compressive stress obtained by the simulations at the base of the tower was compared to the values reported in the literature for similar Italian ancient masonry towers, characterized by similar base vs. height ratio, constructive techniques and elastic properties of the constituting materials [22]. In particular, in Figure 4, the stress value obtained at the base of the tower by the simulations (0.95 MPa) were put in the graph where the compressive stress at ground level of similar monuments were reported. The value obtained are perfectly in agreement with the others and can be considered well validated.

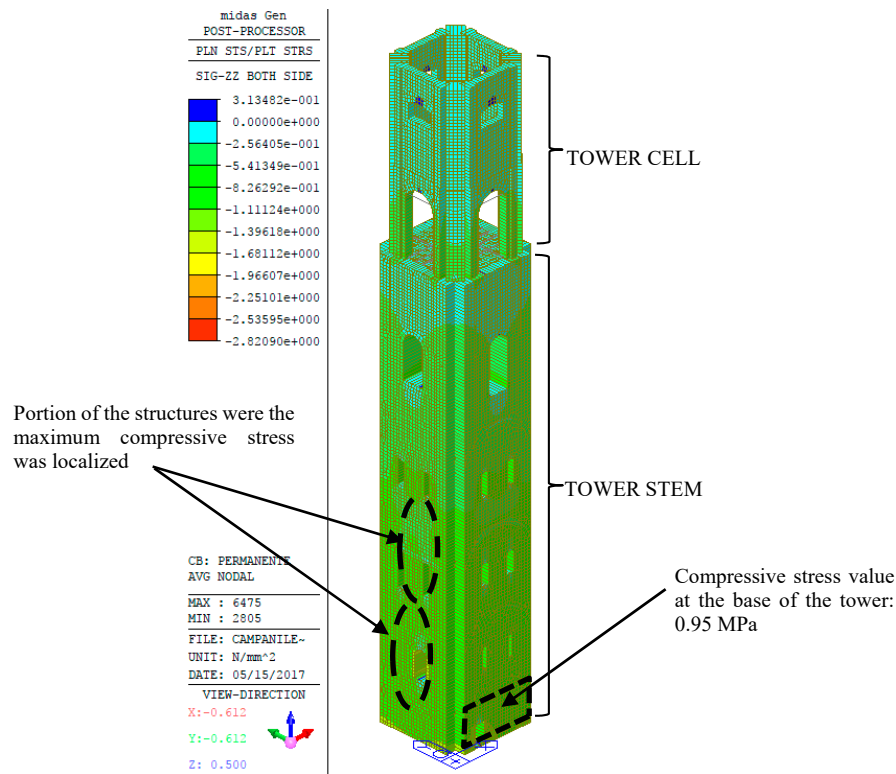
Figure 5. Portion of the structures were the maximum compressive stress was localized. The compressive stress value at the base of the tower is 0.95 MPa.

The results of the static analysis are reported in Figure 5. The value of the compressive stress, as reported previously, was equal to 0.95 MPa at the base of the tower. On the other hand, in a localized portion of the structure, related to the opening disposition, the compressive stress reached higher values up to 1.4 MPa. These values were observed particularly on the south façade of the tower, between the second and the third level.

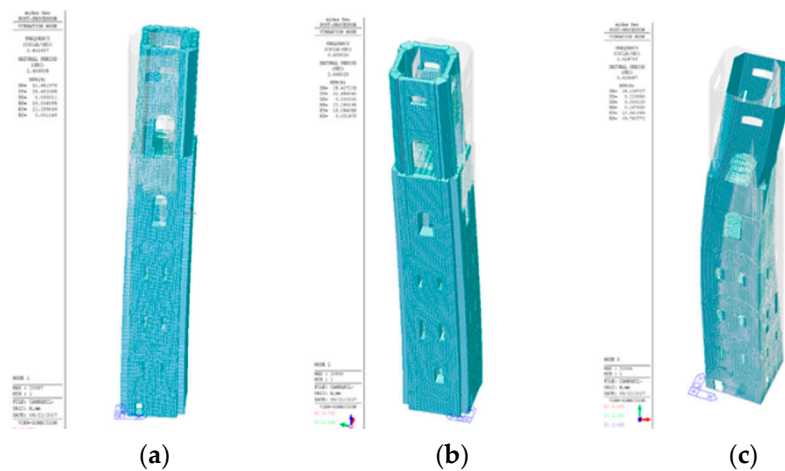
Figure 6. Representation of the modal analysis: (a,b) The two modes of the tower in the y and the x directions, represented by flexural modalities, (c) The third mode showing a torsional modality.

In order to further validate the numerical model, the results of the modal analysis are shown in Figure 6, and the first three vibrating modes were investigated and reported. It can be observed that the first and second modes are flexional, characterized mainly by displacements in x and y directions, while the third is torsional. In Tables 4 and 5, the results of eigenvalue analysis and the masses participating in the individual modes were reported. In the last table, the values of the predominant masses of the

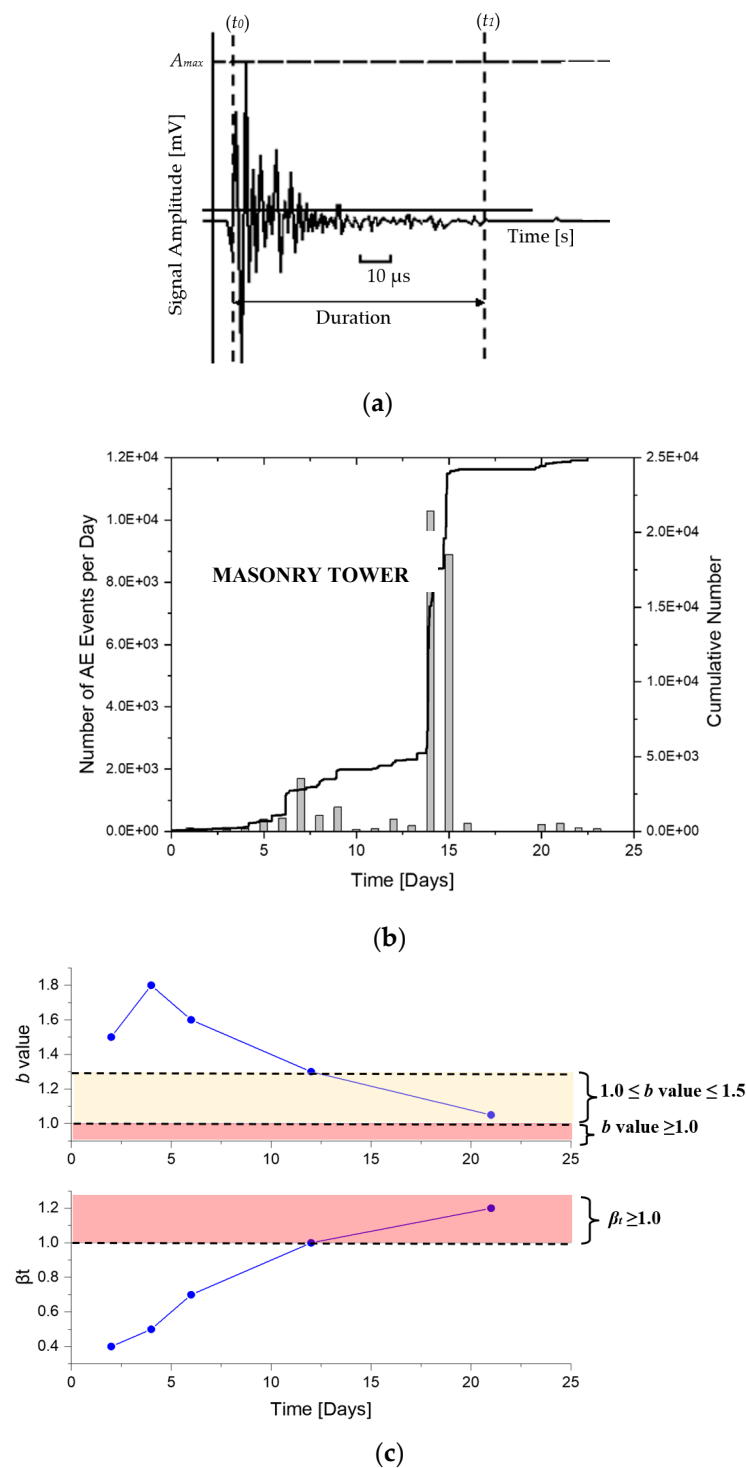
Figure 7. AE signal and AE results of the tower: (a) Typical received signal in the time domain during the acoustic emission (AE) monitoring. The AE equipment used in the present paper allow to set the appropriate threshold value due to the monitored structure and the environmental conditions. (b) Cumulative number of AE and AE count per day during the monitoring time. (c) b -value diagram representing the evolution of the damage, β_t trend evolution during time.

The analysis of the b -value has been widely used for the application of AE analysis. In particular, during the last few decades, very important results were achieved for concrete structures using b -value and improved b -value by Shiotani et al. [27,28]. In present paper, in order to carry out an accurate study, the disturbances of the environment and the noise filters of the instrumentation have been optimized. In particular, a filtering on amplitude signal levels and frequency values is adopted for the AE time series. The b -value trend was obtained working on time windows containing at least 100 AE. Signals with repetitive frequency values or too far from the typical range proper of the frequency of the damage source generation in these types of materials have been discarded. In particular, it is interesting to note that the b -value showed a decreasing trend that is compatible with the growth of macro-cracks localized in the south side of the tower between the second and the third level, in correspondence of the portion of the monitored structure. After 12 monitoring days, the b -value trend entered the $1.5 > b\text{-value} > 1.0$ phase, corresponding to a critical condition (Figure 7c).

In this phase, the localized point started to be found by the triangulation procedure as stated in the following. After 21 monitoring days, the trend approached the local collapse condition $1.0 > b\text{-value}$ (Figure 7c). This phase was correlated with the intensification of the localized point of the damage sources (Figure 8), in correspondence of the evolution of active cracks (Figure 8a,b). Furthermore, as reported in Figure 7c, the growth of the β_t toward values higher than 1.0 in correspondence with the decrease in the b -value highlighted the instability of the crack growth process. As mentioned before, the localization procedure was employed to evaluate the source damage position and the diffusion of the cracking pattern. Localization is one of the most used analysis in AE monitoring. The AE localization technique has been widely applied in laboratory and in situ tests, as well as, has been performed with different methods in order to improve the results accuracy [29–41]. In this second stage (low b -value and higher β_t) in fact, the formation of micro-cracks in a 3D space is analyzed, and the triangulation technique was applied to signals recorded by at least five sensors falling into time intervals sufficiently small (50 μs). Thus, with this procedure, it is possible to define both the position of the micro-cracks in

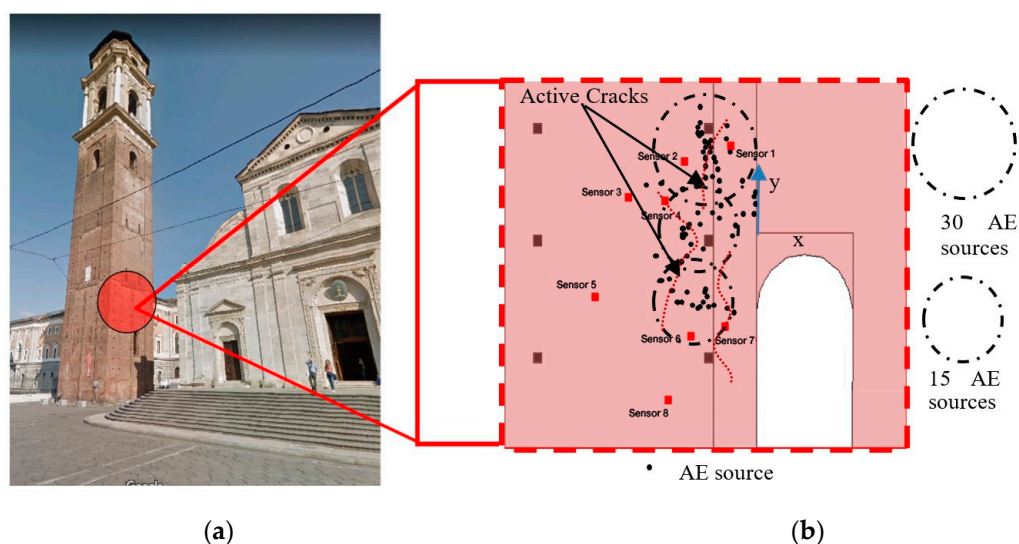
Figure 8. AE localization results. In (a), the portion of the masonry structure where the AE sensors were positioned. The localized points have been indicated with black points, for a total of 62 AE sources (b). Three circles are reported in correspondence to the center of AE source clusters. Two levels of cluster are reported with circle radius proportional to the number of AE source inside the areas. (c) The results of the numerical analysis reported the portion of the structure with higher compressive stress. (d) The same area is reported considering the crack position the erosion areas and the damaged surfaces.

the distance between S_i and source S , in Cartesian coordinates, and assuming the material to be homogenous, the path of the signal is given by $|S - S_i| = v(t_i - t_0')$. If the same event is observed from another sensor S_j at time t_j : $|S - S_j| - |S - S_i| = v(t_i - t_0')$. Assuming the arrival times of the signals and the positions of the two sensors to be known, the last is an equation with four unknowns— x , y , z , and v . Hence, the problem of the localization of S is determined if it is possible to write a sufficient number of equations of that type, i.e., when the same AE event is identified by at least five sensors. If this did not occur, it would be necessary to adopt simplifying assumptions to reduce the degrees of freedom of the problem, such as, for instance, imposing the speed of transmission of the signals or having the AE source lie on predetermined plane. For the analysis carried out in the present research, three-dimensional localizations with at least five sensors were performed. In particular, Figure 8a and Table 6 indicate the position where the sensors were applied, (Figure 8b) the result of the localization with the source points projected on the surface of the facade, (Figure 8c) the relationship with the main results of the numerical model, and (Figure 8d) the detection of damage together with the crack pattern on the same portion of the structure. The localization procedure is based on the principles recently reported by the same authors concerning the signal accuracy [20]. Finally, according to the steps described in the previous section, the sources of AE events were localized. The localized points have been indicated with black points, for a total of 62 AE sources. In the figure, three circles are reported in correspondence to the center of the AE source clusters. Two levels of cluster are reported with circle radii proportional to the number of AE source inside the areas (see Figure 8b). In Figure 8d, the map of surface erosions, masonry gaps, surface damage, and cracks was reported. The AE localization allowed us to identify the portions of the masonry where active and growing cracks were concentrated (Figure 8b). These areas are also those where the highest values in compressive stresses were observed through the numerical model during the static calculus (Figure 8c).

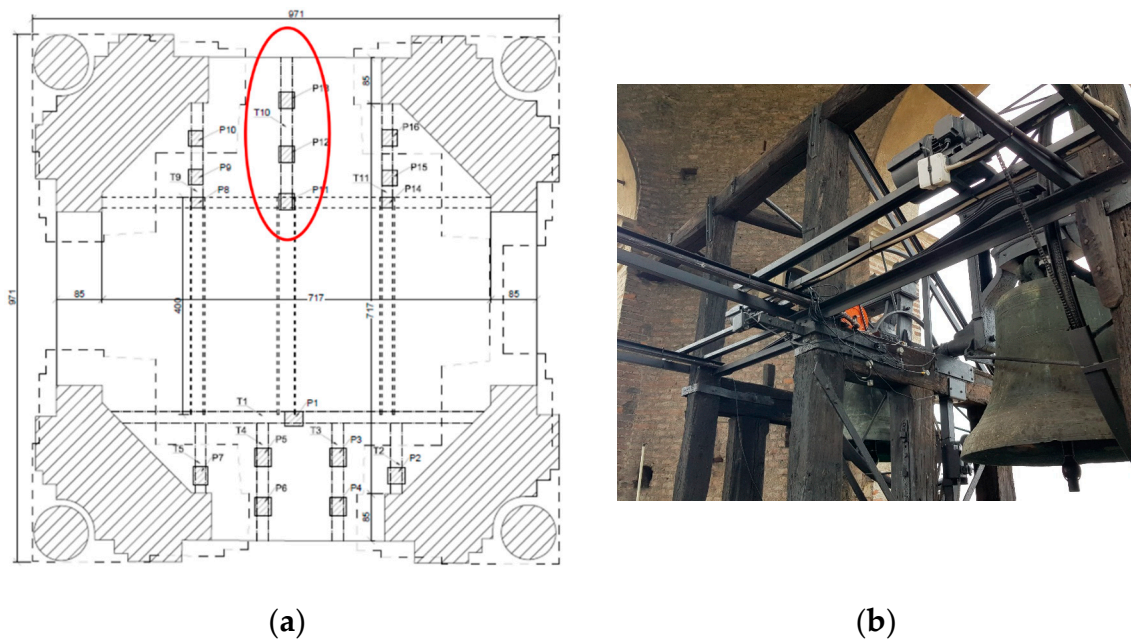
Figure 9. Timber structure positioned inside the bell cell at the top of the tower: (a) Plan of the cell where the timber frame layout is reported. The monitored portion is localized. (b) AE sensors disposition on the wood frame.

The second part of the Bell Tower subjected to the AE monitoring is the timber structure sustaining the bells, positioned inside the bell cell at the top of the tower (see Figure 9). In this case, the wooden structure supporting the bells was monitored with an eight-channel acoustic emission data acquisition system to evaluate the evolution of the cracking pattern evolution over the monitoring time (see Table 7 for the sensor positioning). The sensors were positioned in the wood frame sustaining the heaviest bells, as shown in Figure 8. The structure was monitored for a period of time equal to one month; in particular, the monitoring was carried out from 8 August to 8 September 2019.

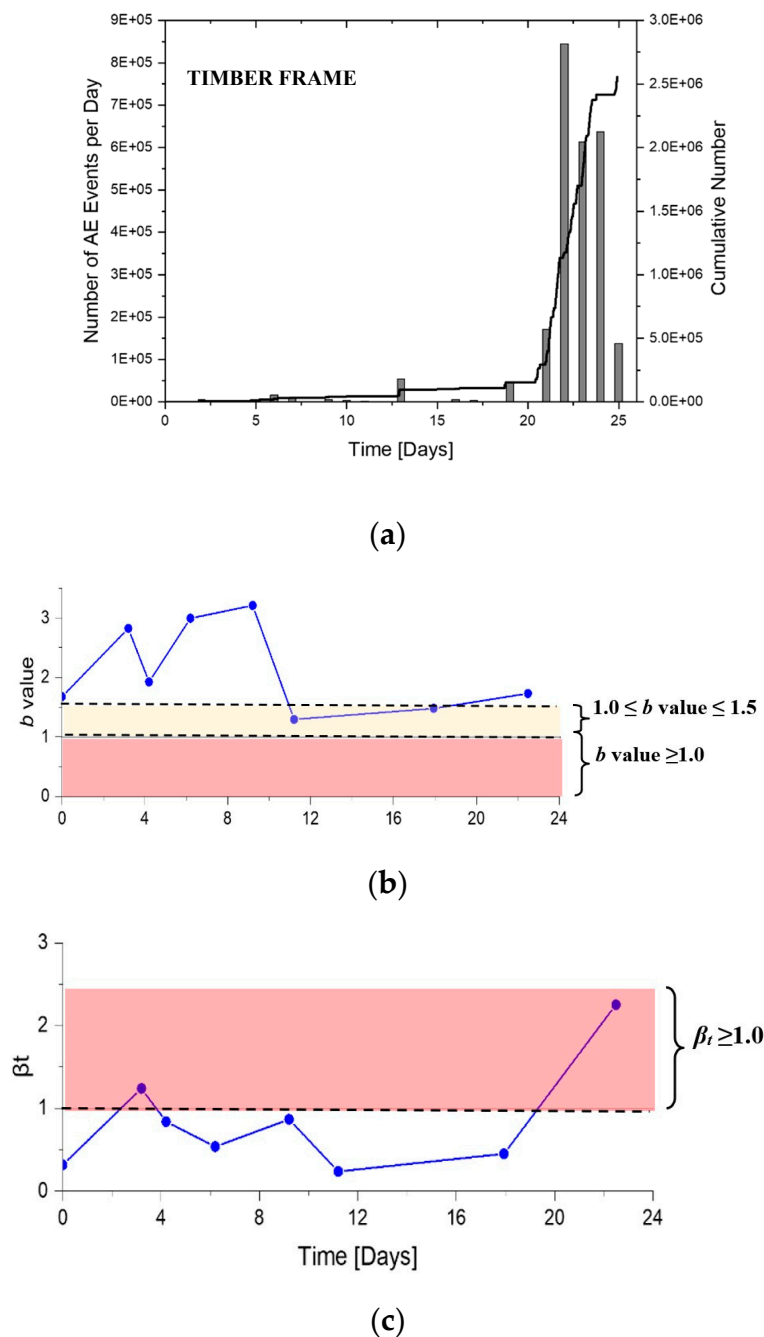
Figure 10. Timber frame of the cell: (a) Cumulative number of AE and AE count per day during the monitoring time. (b) b -value diagram representing the evolution of the damage. (c) β_t trend evolution.

The analysis of the data extracted from the AE device followed similar steps previously observed for the monitoring of the masonry structure of the Bell Tower (see Figure 10). Figure 10a shows the AE cumulative number recorded during the monitoring period and the number of EA events for each day for the timber frame. The b -value trend was obtained working on time windows containing at least 100 AE. As observed in the case of the masonry structure, the b -value assumed numbers greater than 1.5, in correspondence with the first monitoring phase (first 10 monitoring days). After 11 days, the analysis results entered the critical band $1.5 < b\text{-value} > 1.0$ (Figure 10b). In addition, as seen in Figure 10c, the β_t exponent showed an evident growth after 17 monitoring days. This increment is not perfectly correlated with the b -value decrease, but the two phases can be considered just in correspondence.

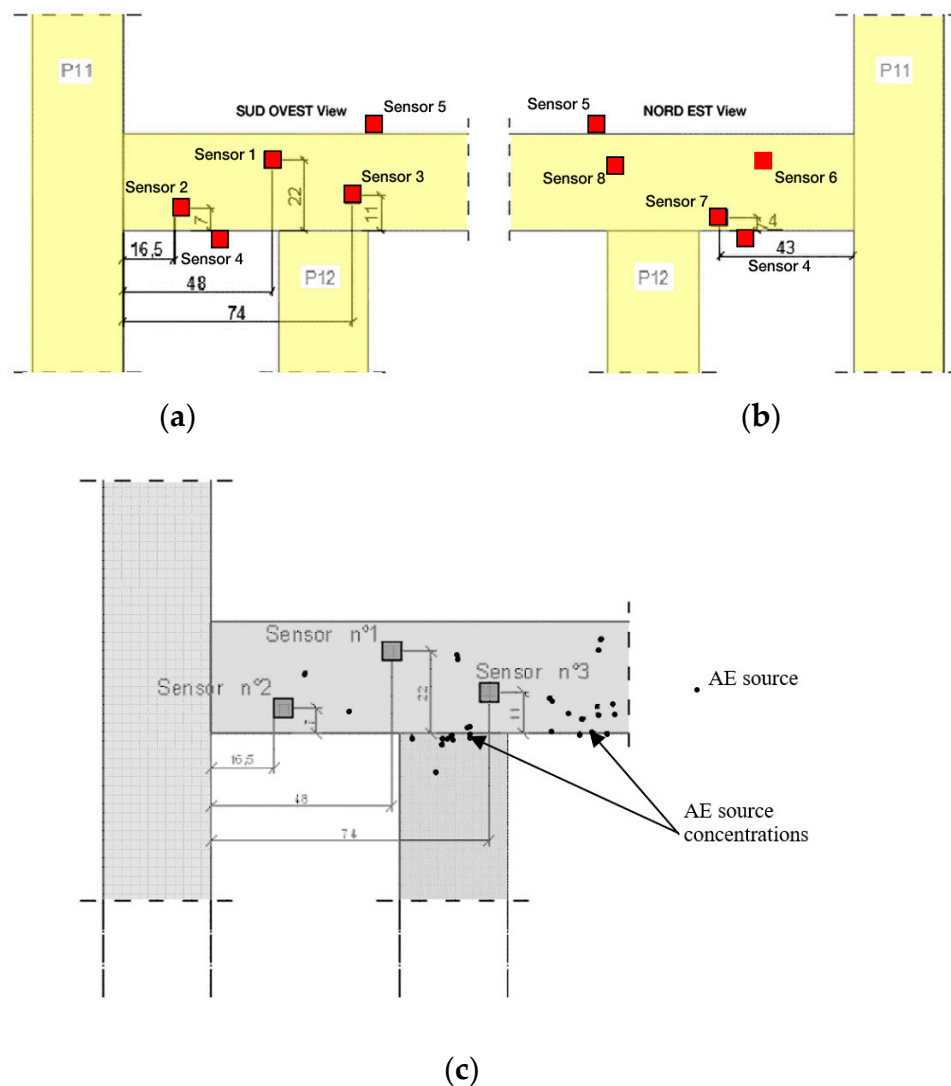
Figure 11. AE localization results. In figure (a) and (b), the portion of the wooden frame where the AE sensors were positioned is showed, (c) The localized points have been indicated with black points, for a total of 24 AE sources.

Finally, the sources of AE events were localized. The position of the sensors and the localized sources are shown in Figure 11a,b. The localized points have been indicated with black points, for a total of 24 AE sources. In this Figure, two circles are reported in correspondence to the barycenter of AE source clusters. Two levels of cluster are reported with circle radii proportional to the number of AE source inside the areas. The results of the AE localization, together with the b -value trend, made it possible to identify the column-beam joint and the portion of the beam close to the pin of the big bell as a portion of the wood frame affected by crack formation and damage growth.

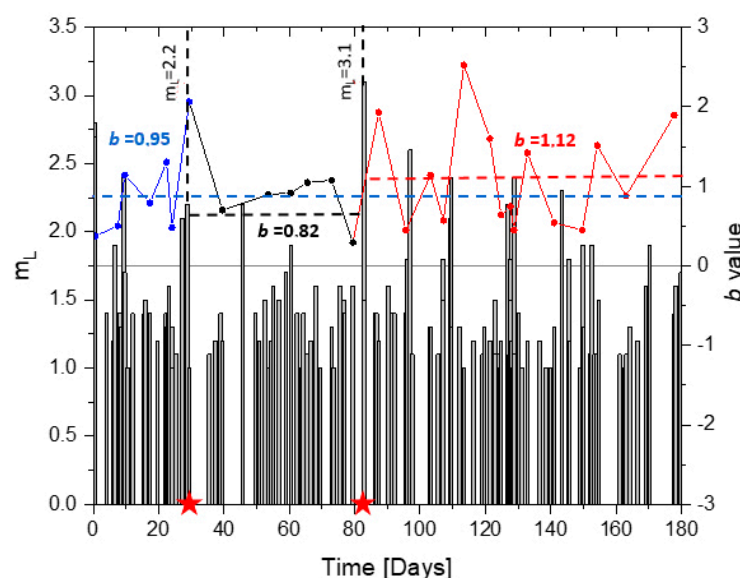
Figure 12. The average b -values before the “anticipator” event (12 April 2018) is equal to 0.95. After this, an evident reduction in the average value equal to 15% is observed (average b -value = 0.82). The main event occurred about 50 days after (5 June 2018). After the m_L : 3.1, no event with greater magnitude were registered for three months.

Therefore, the earthquakes occurred in an area surrounding the bell tower of the Cathedral of Turin were considered in a six-month time window. The events selected are those that occurred between 15 March and 14 September 2018; the monitoring performed by the AE technique on the structures of the Cathedral is located in the final part of the time window here considered. The reference events evaluated in the period have the following characteristics m_L (local magnitude): 2.2 occurred on 12 April 2018 with the epicenter in Massello, a region far from Turin about 86 km, and m_L : 3.1 occurred on 5 June 2018, with the epicenter localized between Italy and France (about 90 km from Turin). The results confirmed (for time series with a lower range in the magnitude levels) the evidence reported by Guglia and Wiemer (2019) [21]. In particular, in Figure 12, the trend of the b -value is reported together with the local magnitude of the seismic events considered. The average value of the b -values before the event considered as the “anticipator” is equal to 0.95, following the seismic event with m_L : 2.2, there is an evident reduction in the average value. The average b -value number decreased of about 15% down to 0.82. Following the main event (m_L : 3.1), which occurred about 50 days after the reduction of the average b -value, an increase of 30% was recorded, and the average b -value was equal to 1.12. The evidence reported in Figure 12 represented a good confirmation that the procedure recently proposed for regions characterized by an intense earthquake activity (high magnitude levels) can be successfully used also for region where the seismic level is lower (Piedmont, northwest of Italy).

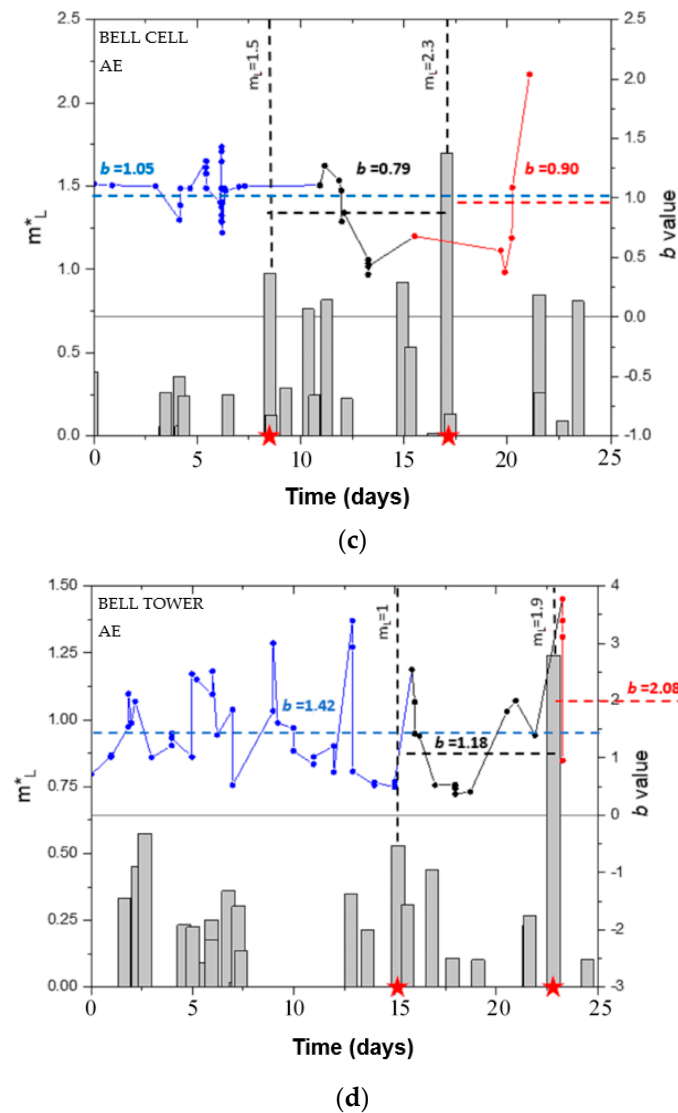
Figure 13. The seismic time series are represented together with the variations of the AE average b -values detected on the structures of the tower: (a,b) b -value time series considering the seismic activity along 40-day time windows. In both the two cases the average b -values demonstrated an evident reduction in correspondence of foreshocks periods between the anticipating and the main event. (c,d) At the same time, the b -value time series have been computed for AE data and correlated to the seismic activity for a period of 25 days contained in the previous larger time intervals.

where m_L^* is the reduced local magnitude; m_L is the actual local magnitude and d is the distance, measured in km, between the epicenter and the Bell Tower of the Turin Cathedral. In Figure 13 the two seismic time series were represented together with the variations of the average b -values.

These variations trends resulted particularly evident for both the two considered periods (10 May 2018–30 June 2018 and 1 August 2019–25 September 2019). For each period, two couples of events were recognized, each of them formed by one anticipant and one main event (the anticipant and the main events are distinguished by stars on the x -axis of the graph). The average values of the b -value before the anticipating events are 1.34 and 2.01 for the two periods, respectively (see Figure 13a,b). The reduced local magnitudes for the two anticipants are $m_L^* = 1.5$ (1 June 2018, Inverso Pinasca, 44°57' N 7°13' E, near Turin); and $m_L^* = 1.0$ (24 August 2019, Torre Pellice, 44°49' N 7°14' E). After these two events two phases, the first of about seven days and the second of about eight days with average b -values of 0.58 and 1.85 were observed for the two time windows. After these intervals, the expected seismic main events $m_L^* = 2.3$ and $m_L^* = 1.9$ took place (Figure 13a,b). These two events were both anticipated by the previously mentioned series where the average b -values encountered reductions of 56% and 8%. After the occurrence of the two events recognized as main events, the b -values trends returned to grow significantly—the average b -values were 1.22 for the first time window
